# **Eurasian Water-milfoil (*Myriophyllum spicatum*) Pre/Post Herbicide and Fall Bed Mapping Surveys Minong Flowage - (WBIC: 2692900) Washburn and Douglas Counties, Wisconsin**

Endangered Resource Services, LLC

April 29, June 15, and October 16, 2016

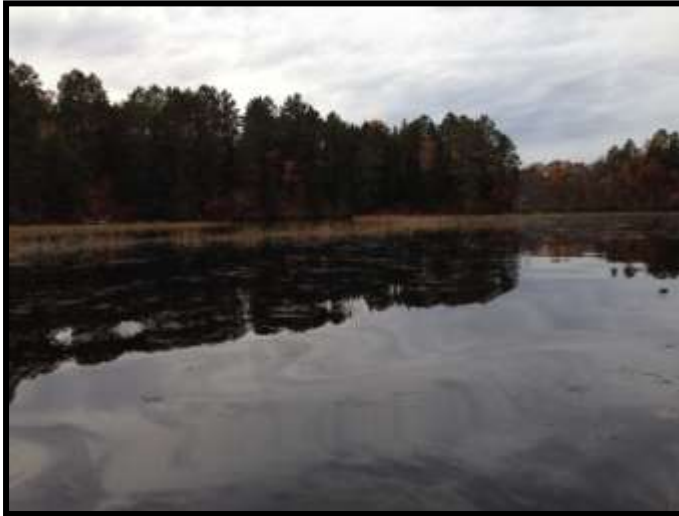
Canopied EWM mixed with wild rice east of Smiths Bridge 10/16/16

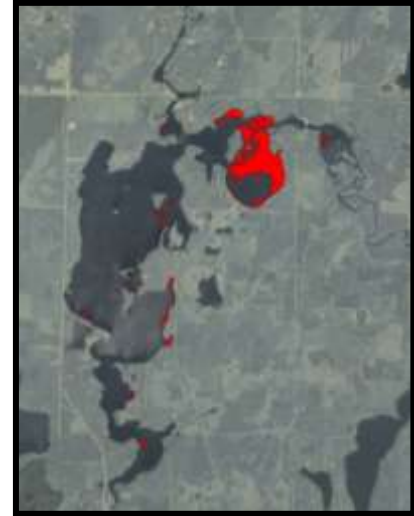
Fall EWM beds 10/16/16

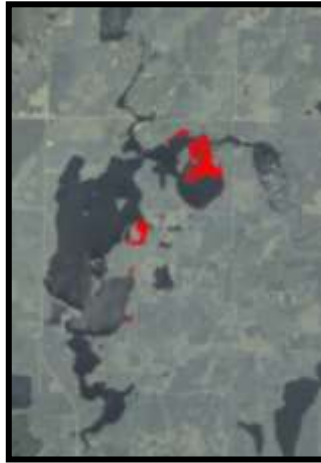
**Figure 1: 2015 Fall EWM Beds**

Eurasian water-milfoil (*Myriophyllum spicatum*) (EWM) was first identified in the Minong Flowage in 2002. From 2009-2011, the Minong Flowage Association (MFA), under the direction of Dave Blumer (Lake Education and Planning Services, LLC - LEAPS), actively managed the infestation using herbicide treatments and manual removal as outlined in the flowage's Wisconsin Department of Natural Resources (WDNR) approved Aquatic Plant Management Plan (APMP). Treatment was suspended in 2012, but the 5ft drawdown to repair the dam in spring 2013 and extended period of freezing over the winter appeared to have killed all surviving terrestrial EWM beds. The subsequent refill in spring 2014 also eliminated most surviving aquatic individuals as the flowage's stained water prevented sufficient light penetration to allow these plants to survive. Unfortunately, EWM quickly began recolonizing shallow habitats that were now largely devoid of any native plants/competition. In fall 2014, we found and mapped ten EWM beds totaling 14.02 acres, and, by fall 2015, this had grown to 11 beds covering 90.36 acres (Figure 1). After analyzing the bed maps, the MFA and LEAPS outlined plans to use herbicide treatment to control EWM in the WDNR boat landing bay on the flowage's east side. Including buffer zones, the treatment area covered 26.90 acres or approximately 1.72% of the flowage's surface area. On April 29<sup>th</sup>, we conducted a pretreatment survey to gather baseline data from the scheduled treatment area and to allow LEAPS to finalize treatment plans. Following the May 16<sup>th</sup> herbicide application, we conducted a June 15<sup>th</sup> posttreatment survey to evaluate the effectiveness of the treatment. We also conducted an October 16<sup>th</sup> bed mapping survey to determine where EWM control might be considered in 2017. This report is the summary analysis of these three field surveys.

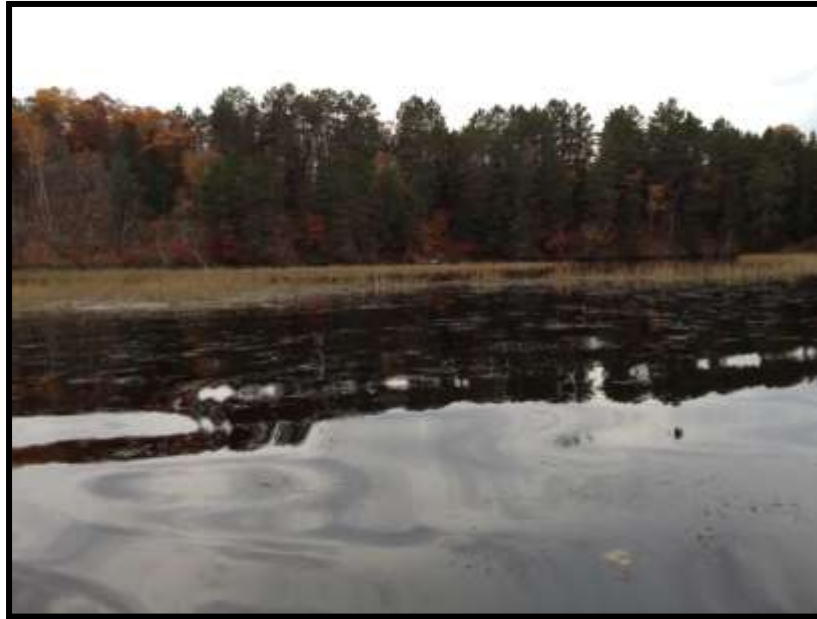
**Figure 15: Canopied EWM Mixed in with Wild Rice  
East of Smith's Bridge 10/16/16**

Bed 19 – EWM in this area underwent a rather dramatic expansion during a year where the rice was largely eliminated by flood water. The resulting bed we found among the rice remnants is now among the worst on the flowage (Figure 15). Unfortunately, it is also the furthest upstream.

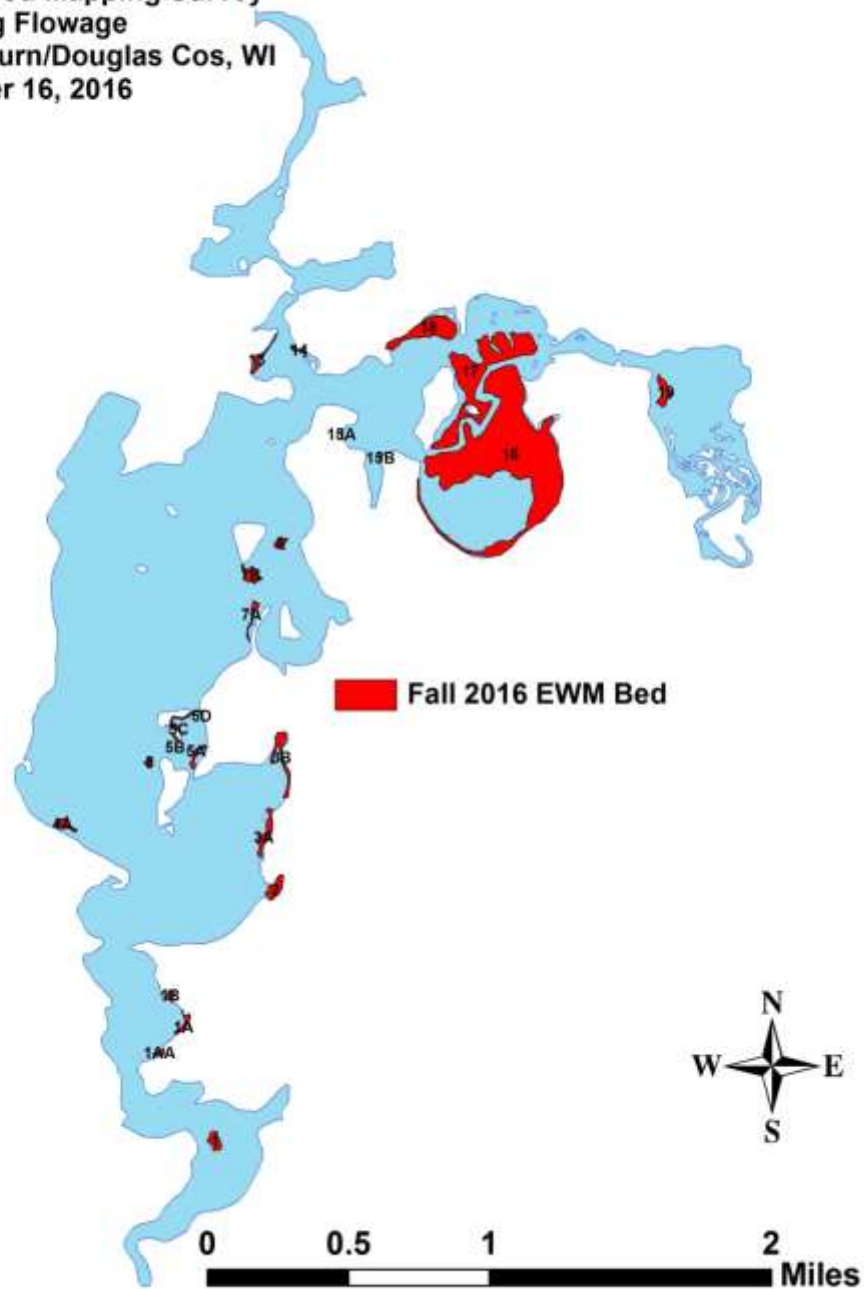
EWM Bed Mapping Survey  
Minong Flowage  
Washburn/Douglas Cos, WI  
October 16, 2016
