**Eurasian Water-milfoil (*Myriophyllum spicatum*)
Late Summer Bed Mapping Survey
Minong Flowage - (WBIC: 2692900)
Washburn and Douglas Counties, Wisconsin**

Endangered Resource Services, LLC
Matthew S. Berg, Research Biologist
St. Croix Falls, Wisconsin
August 30, 2020

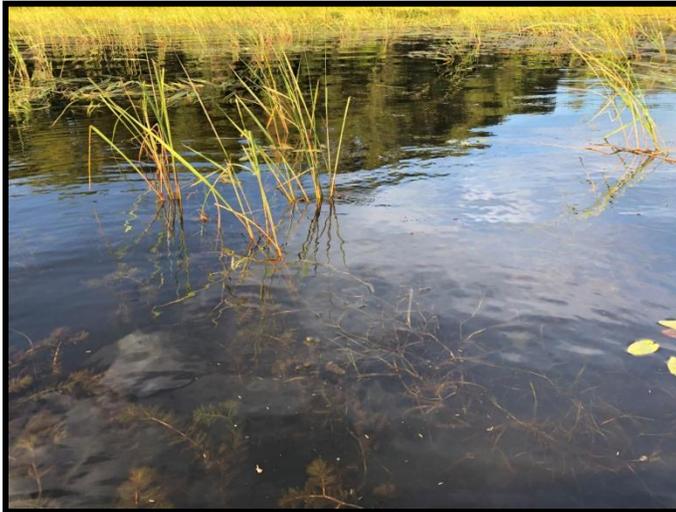
EWM reestablishing among the rice in the Totagatic Inlet 8/30/20

Beds 21 and 22 – EWM was reestablishing among the rice in Bed 21. Although the area covered was still down, plants were denser and healthier than the scattered sickly individuals we documented on the 2019 report cover. We saw no evidence of EWM in the area formerly covered by Bed 22.

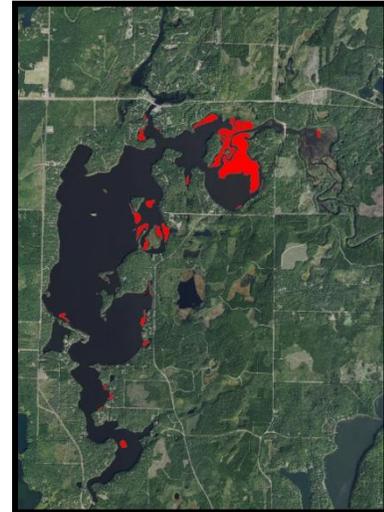
August 2020 EWM Beds

During the August 2020 survey, we located and mapped 28 Eurasian water-milfoil beds that covered 112.13 acres or 7.17% of the flowage's surface area (Figure 3) (Appendix I). This was an increase of 26.86 acres (+31.50%) from the 2019 survey when we mapped 25 beds totaling 85.27 acres (5.45% coverage) (Table 1). It was, however, still **-20.97%** below the 2018 fall survey when we mapped 31 beds totaling 141.88 acres (9.07% coverage) (Table 2).

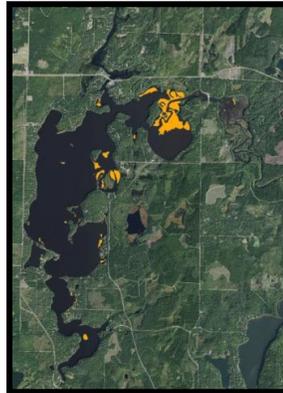
Figure 1: 2019 August EWM Beds

Following the drawdown, EWM quickly began recolonizing shallow habitats that were now largely devoid of any native plants/competition. During our fall 2014 EWM bed mapping survey, we found just ten beds totaling 14.02 acres; but, by fall 2015, this had grown to 11 beds covering 90.36 acres. In 2016, the MFA used herbicides to treat a single EWM bed that covered 26.90 acres in the WDNR boat landing bay on the flowage's east side. Although this area remained clear throughout the rest of the growing season, our 2016 fall mapping survey found 24 EWM beds covering 125.58 acres scattered throughout the rest of the flowage. This total jumped to 27 beds but shrank to 112.88 acres in 2017 before ballooning to 31 beds covering 141.88 acres in 2018 (9.07% of the flowage's surface area). Inexplicably, the August 2019 survey (Figure 1) documented a sharp decline in both the number and coverage of beds (25 beds/85.27

acres/5.45% of the flowage’s surface area). We also noted the EWM appeared to be in very poor health with many plants presenting blackened stems and only a whorl or two of green leaflets (see cover of 2019 report). As in 2018 and 2019, because most of these beds occurred in the northeast bays, it was ultimately decided **NOT** to do any active management on the flowage in 2020. However, in order to track EWM’s coverage and to determine if levels would justify a future drawdown or other management, LEAPS, the MFA, and the WDNR requested a EWM bed mapping survey on August 30, 2020. This report is the summary analysis of that survey.

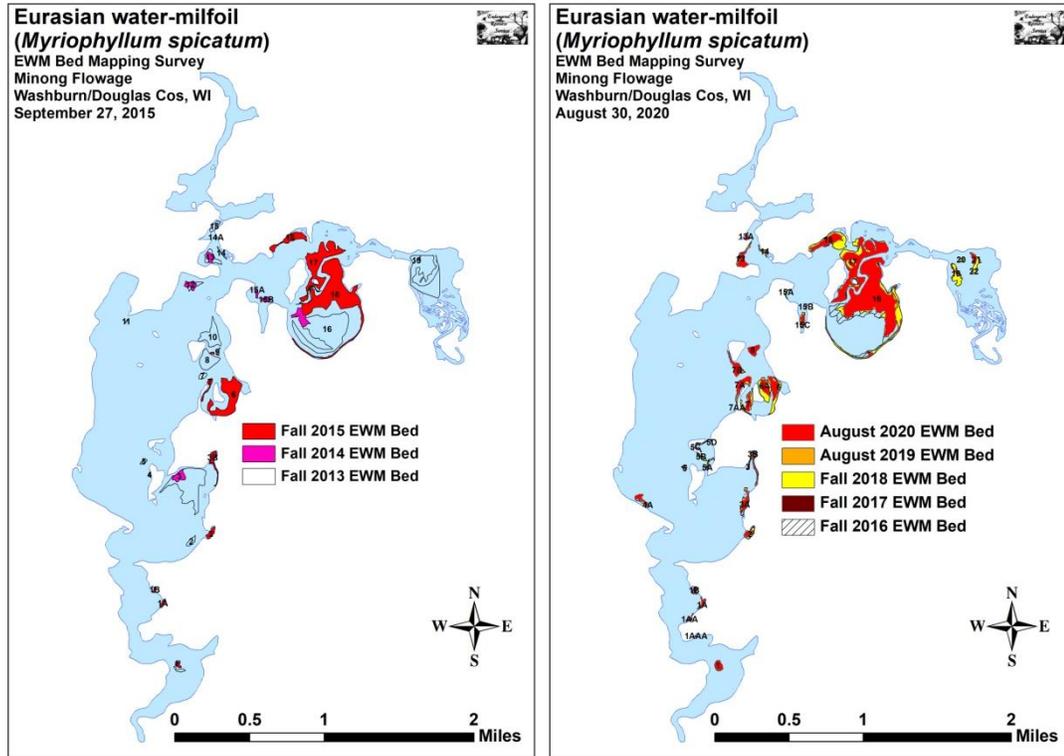
Figure 3: Late Summer/Fall EWM Beds 2013-2015 and 2016-2020

Most of the increase in coverage seen in 2020 came from low density EWM filling in gaps and expanding along the edges of previously identified beds in the northeast bays. Despite these increases, many plants in these bays again seemed dormant or nearly so.

Conversely, in the bays south of the CTH T bridge and in the south basin, we documented a general uptick in plant health with most beds showing active canopied growth. This was accompanied by a noticeable increase in floating fragments which were common to abundant; especially near the county campground and in the beds in and around the WDNR boat landing bays. Regardless of the location, EWM plants continued to be absent at most depths over 4ft.
