**Eurasian Water-milfoil (*Myriophyllum spicatum*)  
Late Summer Bed Mapping Survey  
Minong Flowage - (WBIC: 2692900)  
Washburn and Douglas Counties, Wisconsin**

**Survey Conducted by and Report Prepared by:**

Endangered Resource Services, LLC  
Matthew S. Berg, Research Biologist  
St. Croix Falls, Wisconsin  
September 19, 2021

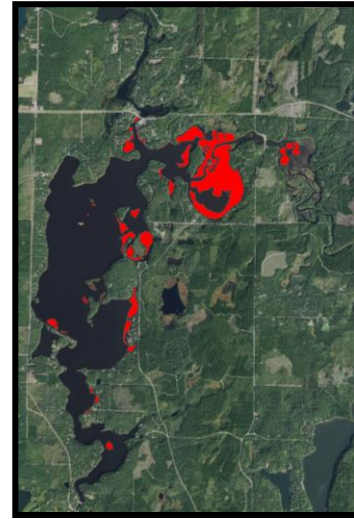
EWM among the rice in the Totagatic Inlet 9/19/21

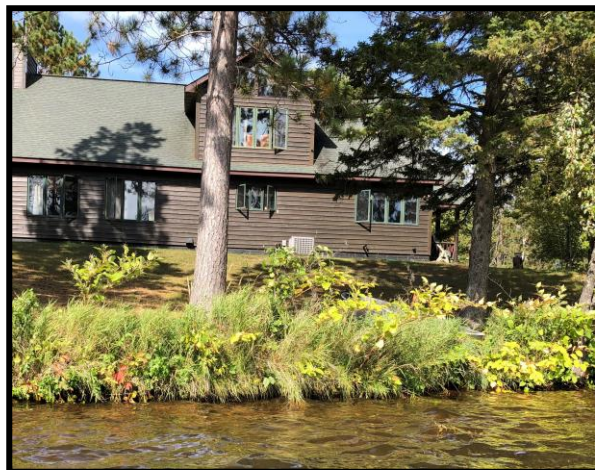
Japanese knotweed – a new exotic species found on the flowage 9/19/21

In addition to EWM, we noted that the Japanese knotweed we first documented in 2020 had started to expand along the shoreline. This aggressive exotic species can be difficult to control once established, and we again encourage the board to work with the landowner to immediately remove the plants present (see cover of the report showing clusters of plants along the shoreline of a brown house just east of the "T" when leaving the south basin at GPS DD coordinates N46.16724 W91.92250).

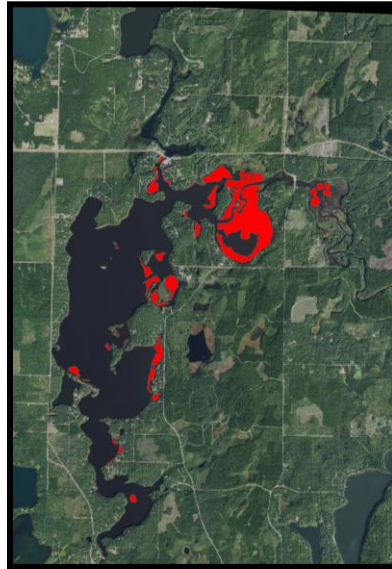
**Figure 1: 2021 September EWM Beds**

The Minong Flowage (WBIC 2692900) is a 1,564-acre eutrophic/mesotrophic drainage lake located in north-central Washburn County and south-central Douglas County, Wisconsin in the Towns of Minong and Wascott (T42N R13W) (Figure 1). It reaches a maximum depth of 21.5ft near the dam on the far south end and has an average depth of approximately 9ft. The bottom is predominately sand and sandy muck in the south basin and organic muck in the northern bays. Secchi disc readings from 1994-2021 have ranged from 2-6ft and averaged 3.9ft (WDNR 2021). This poor to very poor clarity produced a littoral zone that extended to a maximum of 10ft in 2021.
