Eurasian Water-milfoil (*Myriophyllum spicatum*) Late Summer Bed Mapping Survey Minong Flowage - (WBIC: 2692900) Washburn and Douglas Counties, Wisconsin

September 2022 EWM Beds

Endangered Resource Services, LLC Matthew S. Berg, Research Biologist St. Croix Falls, Wisconsin September 24, 2022

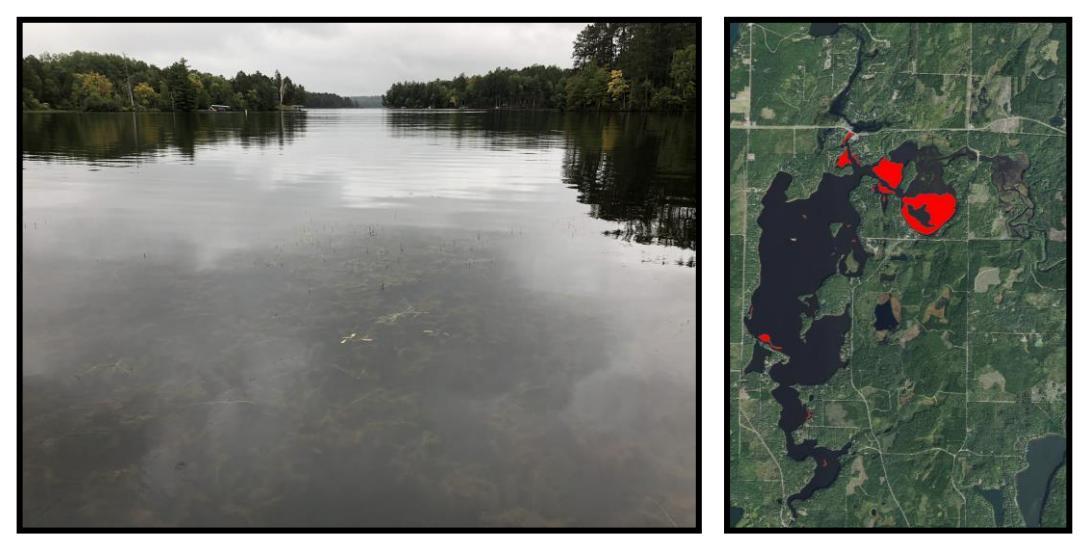
Dense mat of EWM in channel southeast of Pogo's 9/24/22

Bed 13 – The majority of the bay was a moderate impairment as the bed continued to expand into deeper and deeper water. We found plants were regularly canopied in more than 10ft and were growing right up to the river channel boundary (see report cover).

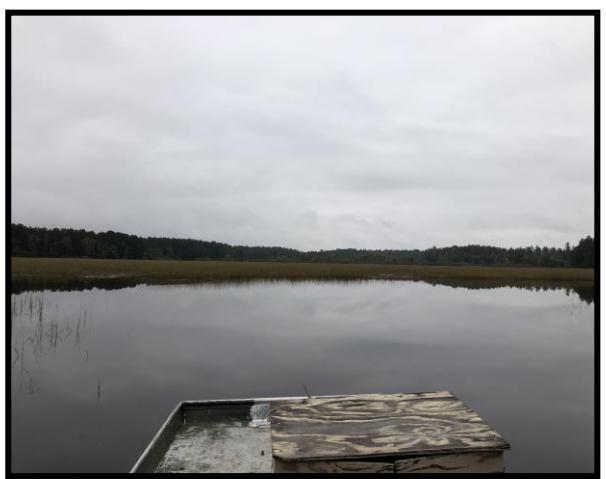
Wall of Northern wild rice east of Smith's Bridge 9/24/22

Beds 19, 20, 21, and 22 - East of Smith's Bridge, Northern wild rice had taken over most of the delta. The only EWM seen was a few scattered plants located in the river channels. Outside of these areas, all milfoil plants seem to have been killed by the drawdown.

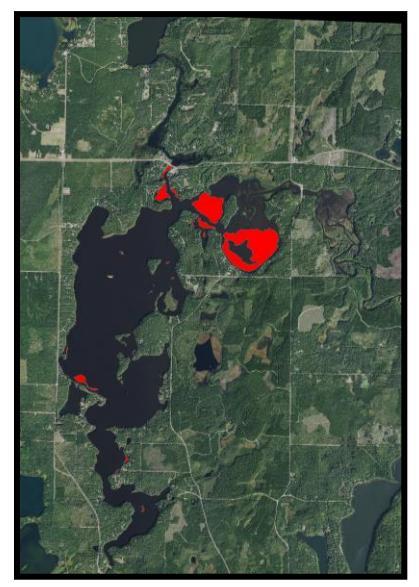
Figure 1: 2022 September EWM Beds

The Minong Flowage (WBIC 2692900) is a 1,564-acre eutrophic/mesotrophic drainage lake located in north-central Washburn County and south-central Douglas County, Wisconsin in the Towns of Minong and Wascott (T42N R13W) (Figure 1). It reaches a maximum depth of 21.5ft near the dam on the far south end and has an average depth of approximately 9ft. The bottom is predominately sand and sandy muck in the south basin and organic muck in the northern bays. Secchi disc readings from 1994-2021 (the most recent year available) have ranged from 2-6ft and averaged 3.9ft (WDNR 2022). This poor to very poor clarity produced a littoral zone that extended to a maximum of 11ft in 2022.

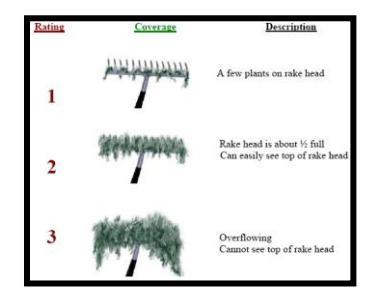
Figure 2: Rake Fullness Ratings

During the bed mapping survey, we searched the flowage's visible littoral zone. By definition, a "bed" was determined to be any area where we visually estimated that Eurasian water-milfoil made up >50% of the area's plants, was generally continuous with clearly defined borders, and was canopied, or close enough to being canopied that it would likely interfere with boat traffic. Once located, we motored around the perimeter of the area taking GPS coordinates at regular intervals. We also estimated the rake density range and mean rake fullness of the bed (Figure 2), the range and maximum depth of the bed, whether it was canopied, and the impact it was likely to have on navigation (**none** – easily avoidable with a natural channel around or narrow enough to motor through/**minor** – one prop clear to get through or access open water/**moderate** – several prop clears needed to navigate through/**severe** – multiple prop clears and difficult to impossible to row through). These data were then mapped using ArcMap 9.3.1, and we used the WDNR's Forestry Tools Extension to determine the acreage of each bed to the nearest hundredth of an acre.

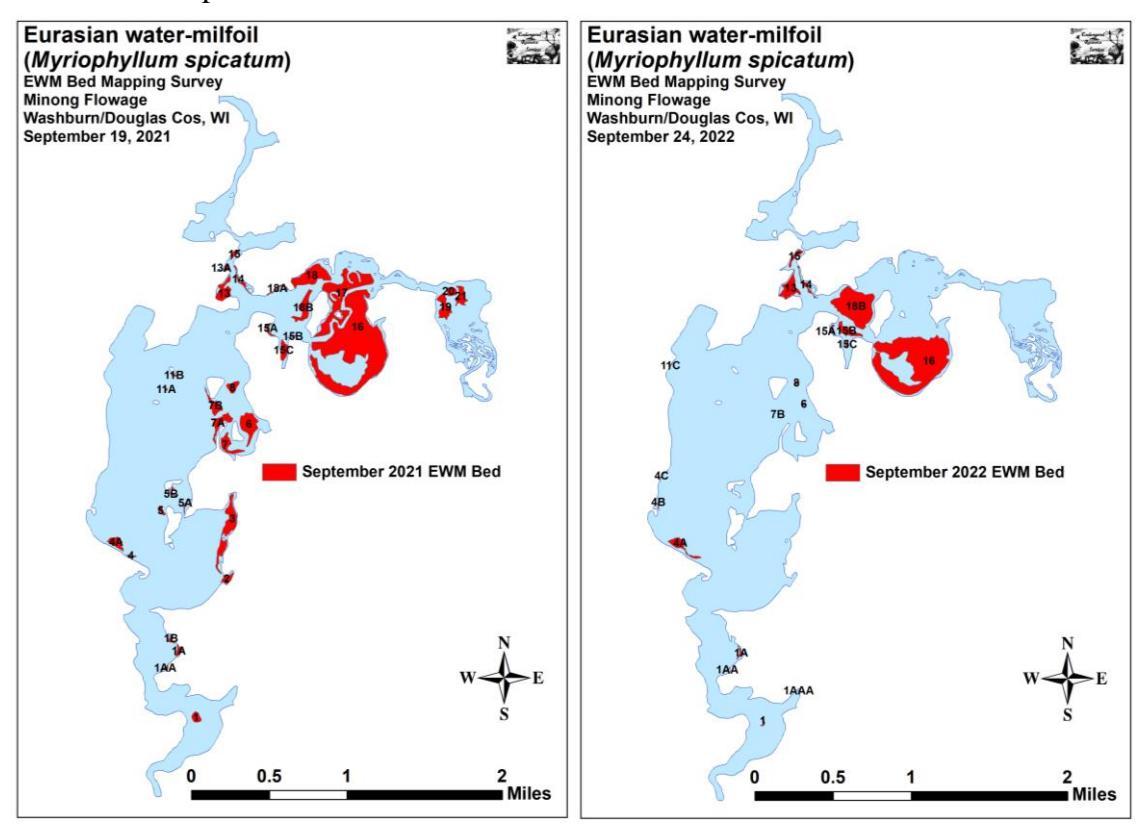
Figure 3: Late Summer/Fall EWM Beds 2021 and 2022

During the September 2022 survey, it was immediately apparent to us that the second drawdown did not provide the hoped for reset of the Eurasian water-milfoil population as the first drawdown had. Ultimately, we mapped 19 beds totaling 116.13 acres or 7.43% of the flowage's surface area (Figure 3) (Appendix I). Although this was a decline of 89.72 acres (-43.59%) from the 34 EWM beds covering 205.85 acres (13.16% surface area) we found immediately prior to the drawdown, there were still large upstream areas covered by EWM beds (Table 1). The 2022 total was also higher than the 28 beds on 112.13 acres (7.17% coverage) we mapped in 2020 (Table 2).

Most of the decline in coverage seen post-drawdown came from the southern basin where plants were seldom found in water deeper than 5ft in 2021. In the northern bays, EWM seemed to have continued its deepwater expansion almost uninterrupted. Unfortunately, we also noted floating fragments were abundant throughout the entire flowage as upstream boat traffic was regularly prop-clipping beds. Although most of these beds were still only causing minor impairment to watercraft, most were trending towards moderate impairment (Table 1). Specifically, we noted residents in these northern bays that have had minimal EWM for more than a decade were often forced to cut through canopied or near canopied beds to access open water.
